## NF P01-013 Testing Report

Report Number KNFP010132103  
Revision Number -

**Name and definition of the sample** : KE 100 -Railing

**Procedure** : NF P01-013:1998-08 Railings tests - Determination Of The  
Mechanical Strength Under Distributed Static Loads and  
Determination Of The Mechanical Strength Under Dynamic Loads

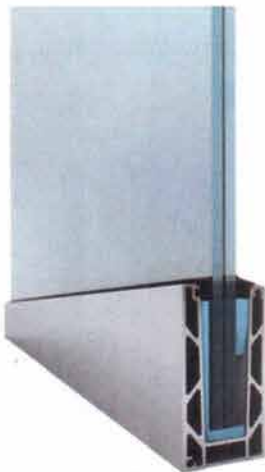
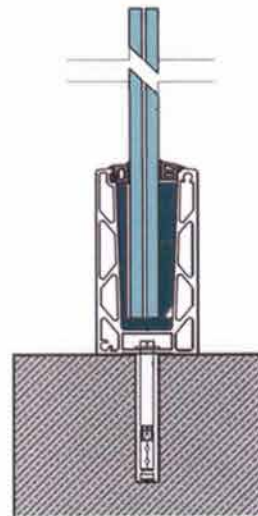
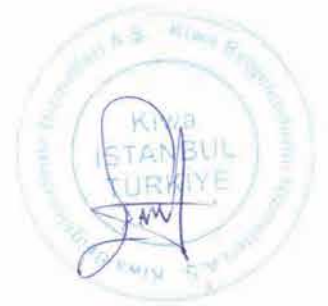
### Sample schematic drawing of the product

The railing system consists of the parts listed below.  
Total length:1000mm  
Height:1200mm

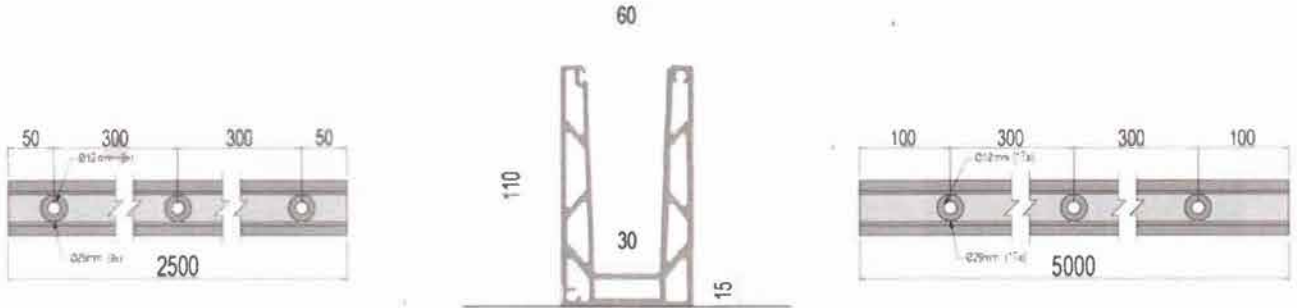
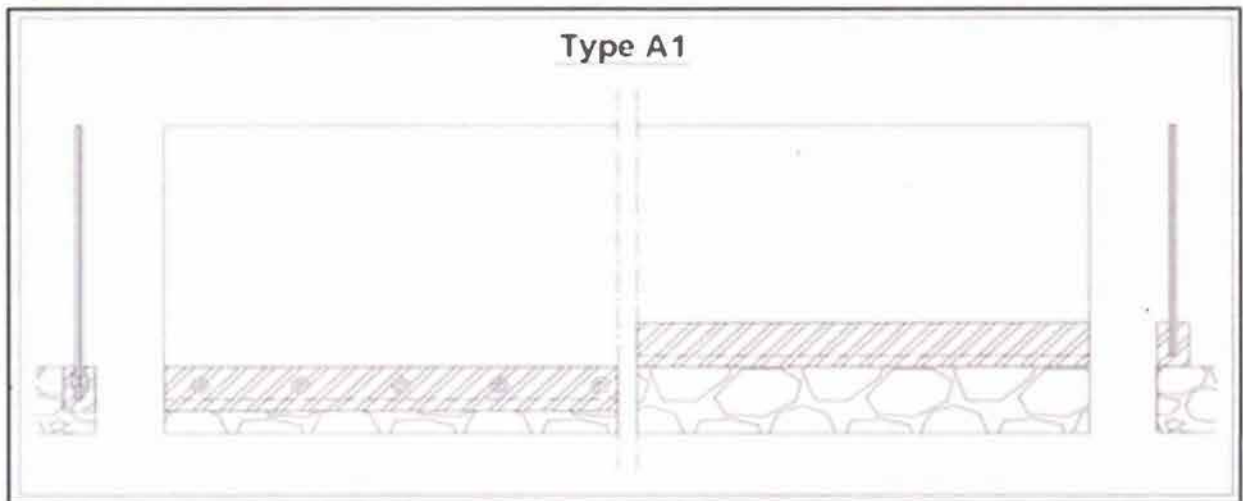
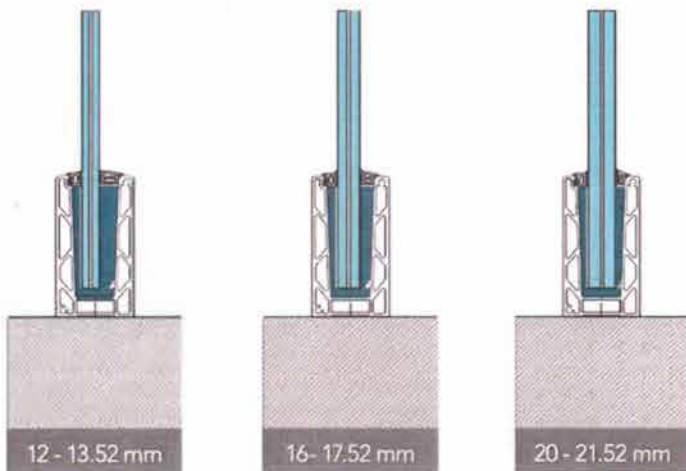
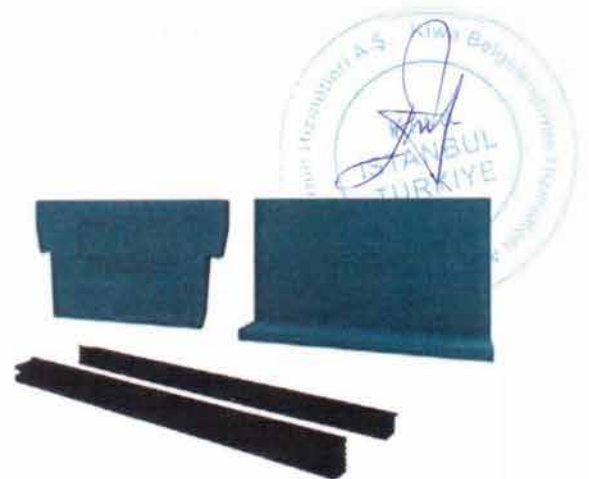
KE 100 Balustrade profile were tested for three glass thicknesses (13.52mm, 17.52mm and 21.52mm)

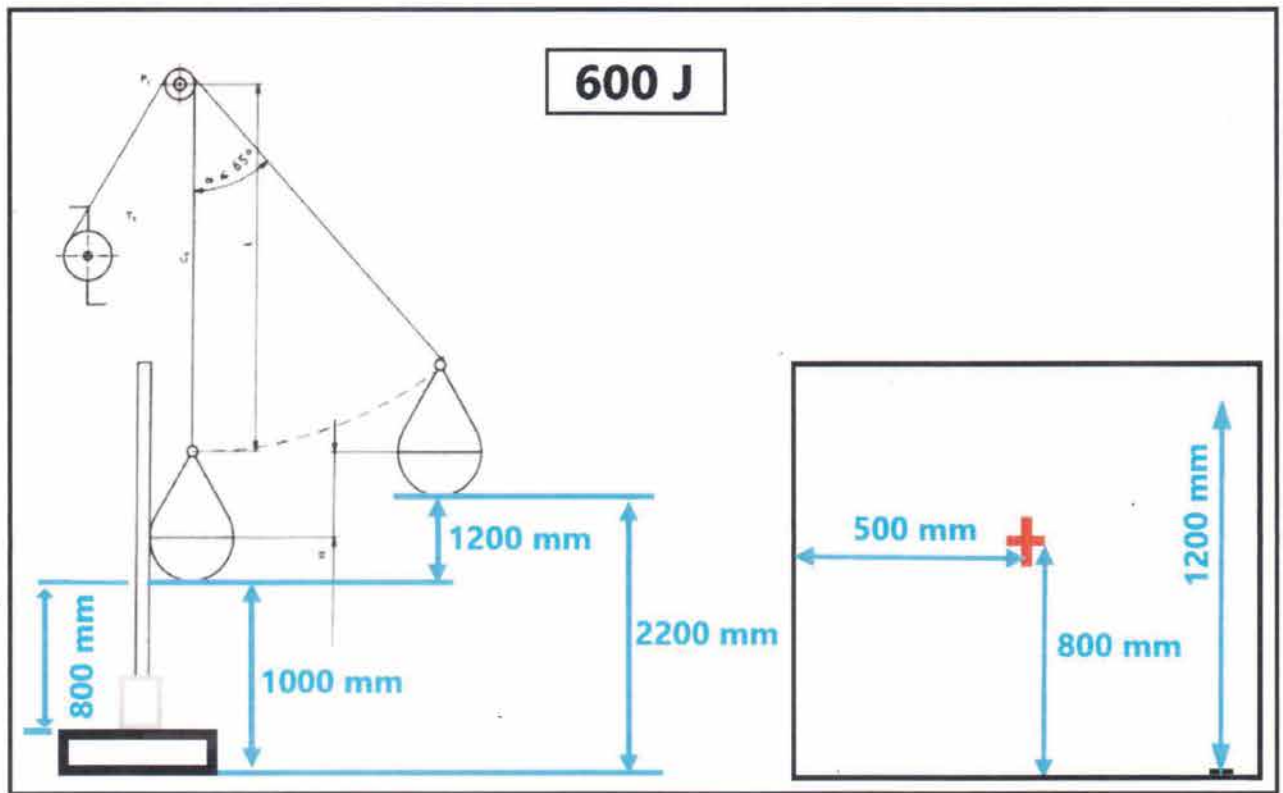
The product was released from the height of 1200 mm, with a diameter of 40 cm and a weight of 50 kg, filled with glass balls with a diameter of 3 mm, and the resulting changes in the resultant impact were observed.

| Impact area | Drop height | Glass thickness(mm) | Energy | Deformation amount of glass(mm) | Result (1) | |
|---|---|---|---|---|---|---|
| Midpoint | 1200mm | 21,52 | 600J | 73,74 mm | 4 | Compliant |
| | 1200mm | 17,52 | 600J | 36,39 | 4 | Compliant |
| | 1200mm | 13,52 | 600J | 78,82 | 4 | Compliant |
