## NF P01-013 Testing Report

Report Number KNFP010132103  
Revision Number -

**Name and definition of the sample** : KE 105 -Railing

**Procedure** : NF P01-013:1998-08 Railings tests - Determination Of The  
Mechanical Strength Under Distributed Static Loads and  
Determination Of The Mechanical Strength Under Dynamic Loads

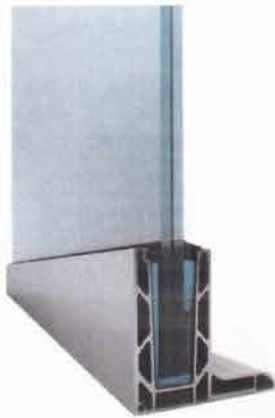
### Sample schematic drawing of the product

The railing system consists of the parts listed below.

Total length: 1000mm

Height: 1200mm

MODEL – KE 105			
NO	DESCRIPTION OF GOODS	RAW MATERIALS	Quantity
1	10+1,52+10mm GLASS	10+1.52+10 GRINDING + LAMINATED GLASS (1200 Height x 1000 Width x 21.52 Thickness)	2
2	8+1,52+8mm GLASS	8+1.52+8 GRINDING + LAMINATED GLASS (1200 Height x 1000 Width x 17.52 Thickness)	2
3	6+1,52+6mm GLASS	6+1.52+6 GRINDING + LAMINATED GLASS (1200 Height x 1000 Width x 13.52 Thickness)	2
4	KE 105 Balustrade Profile (1 Meter)	Aluminum 6063 T6	6
5	M10 Anchors	Total of 3 anchors for 1 meter with an interval of 300mm	18
6	Green Installation Plastics for 10+1,52+10mm Glass	ABS HI121H Plastik mechanism to ensure the perpendicularity of glass.	8
7	Blue Installation Plastics for 8+1,52+8mm Glass	ABS HI121H Plastik mechanism to ensure the perpendicularity of glass.	8
8	Red Installation Plastics for 6+1,52+6mm Glass	ABS HI121H Plastik mechanism to ensure the perpendicularity of glass.	8
11	Compression and outside rubber	Total of 2 pieces (each one has a length of 1 meter) for each profile.	12

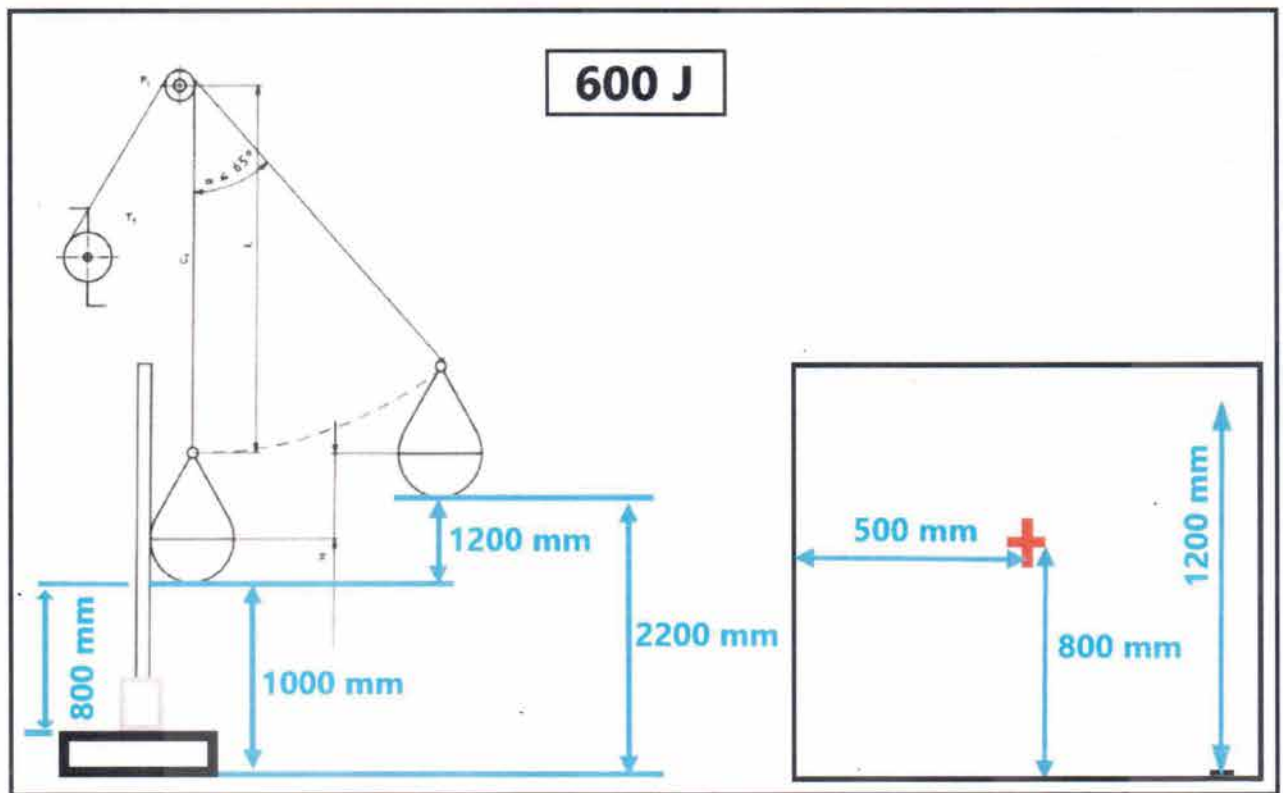
The product was released from the height of 1200 mm, with a diameter of 40 cm and a weight of 50 kg, filled with glass balls with a diameter of 3 mm, and the resulting changes in the resultant impact were observed.

Impact area	Drop height	Glass thickness(mm)	Energy	Deformation amount of glass(mm)	Result (1)
Midpoint	1200mm	21,52	600J	75	Compliant
	1200mm	17,52	600J	80	Compliant
	1200mm	13,52	600J	50	Compliant
