**NF P01-013 Testing Report**

Report Number KNFP010132103  
Revision Number -

**Name and definition of the sample** : KE 120 -Railing

**Procedure** : NF P01-013:1998-08 Railings tests - Determination Of The  
Mechanical Strength Under Distributed Static Loads and  
Determination Of The Mechanical Strength Under Dynamic Loads

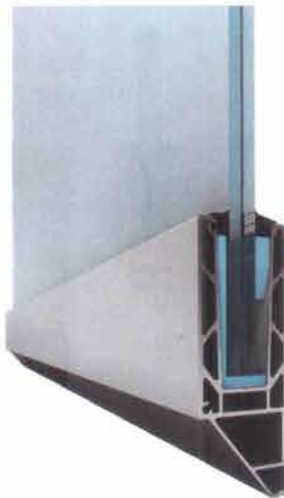
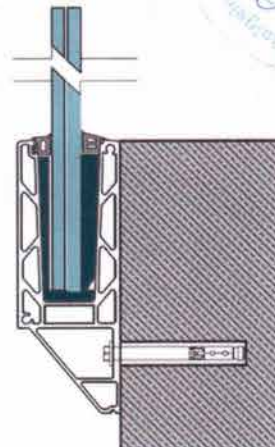
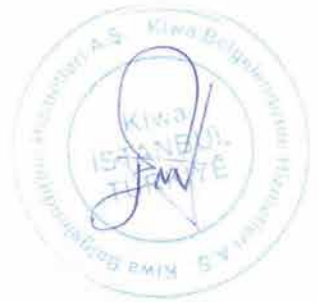
### Sample schematic drawing of the product

The railing system consists of the parts listed below.

Total length: 1000mm

Height: 1200mm

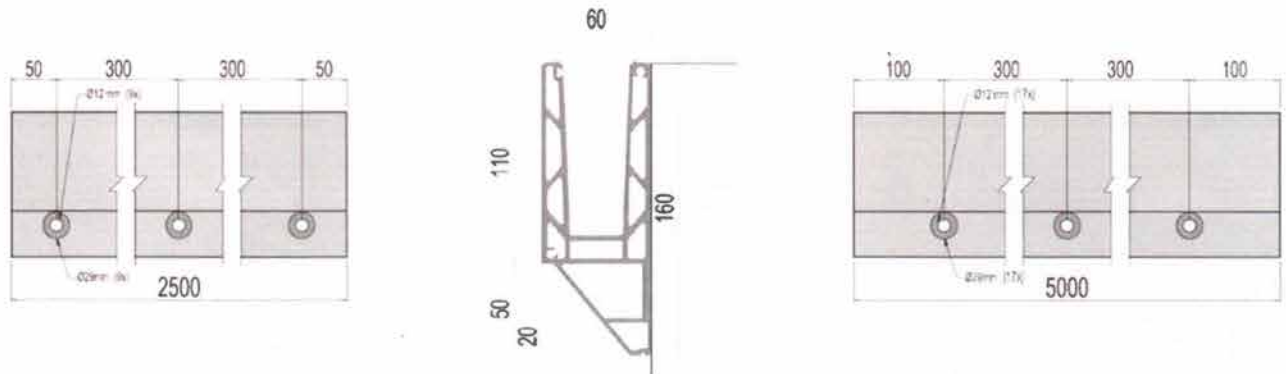
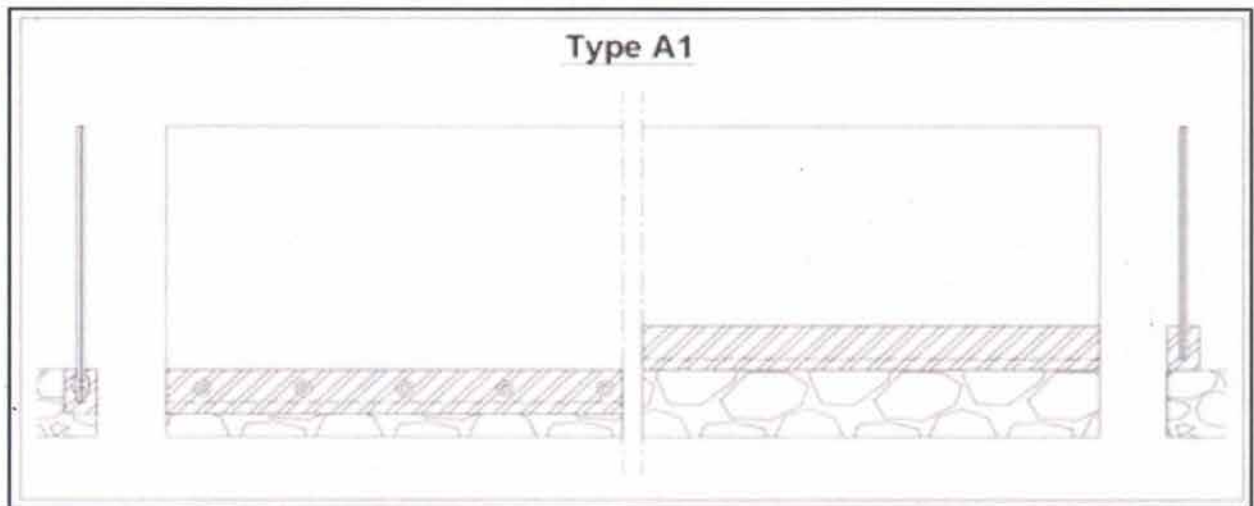
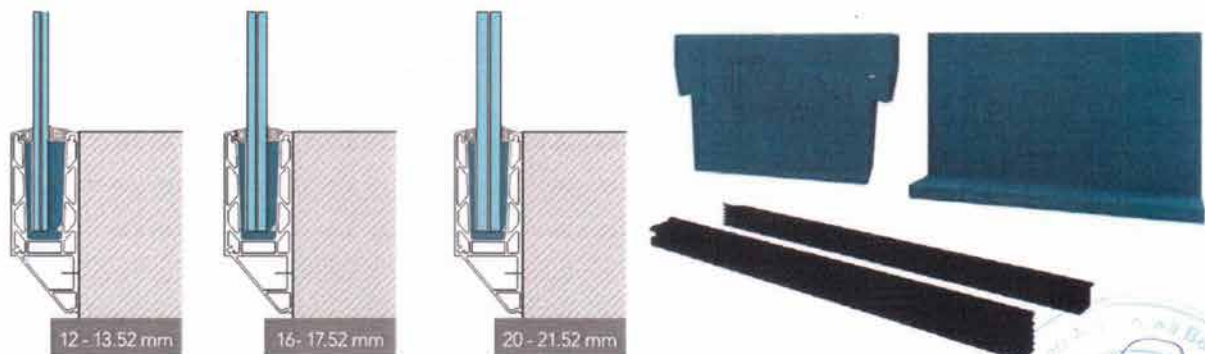
KE 120 Balustrade profile were tested for three glass thicknesses (13.52mm, 17.52mm and 21.52mm)
